# Manhole Inspection Summary

Manhole # S02AA2042MH

**Location** Address: **3403 BANCROFT RD**

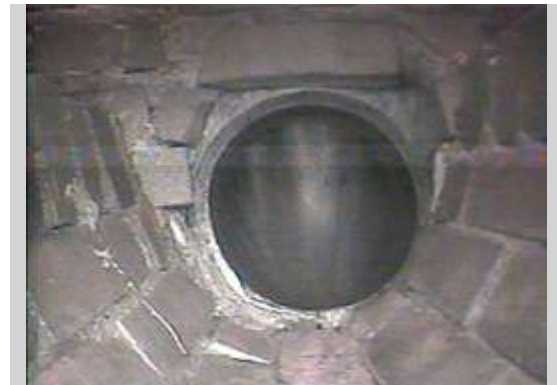
### Drop In @ 6 O'Clock

Drop: **Outside** Rod and Bar

Angled: **Yes** Reading: **8.65** (ft.)

Drop Condition: **Open**
